INSTALLATION RESTORATION PROGRAM

PHASE I - RECORDS SEARCH

DYESS AFB, TEXAS

July 1985

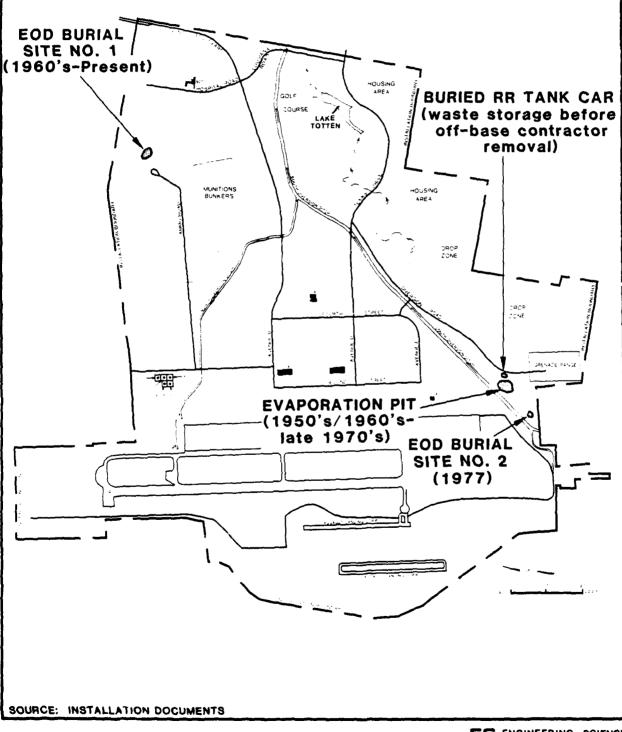
EVAPORATION PIT, EOD BURIAL SITES AND WASTE STORAGE TANK

The tank car was pumped out for a final time in 1982 and the structure remains abandoned in its original location. Sludge accumulated in the tank is believed to remain. No testing was ever performed to assess the structural integrity of the tank.
